Evaluation of Concrete Pavement Repair Using Precast Technology in Virginia

Shabbir Hossain¹ and Celik Ozyildirim²

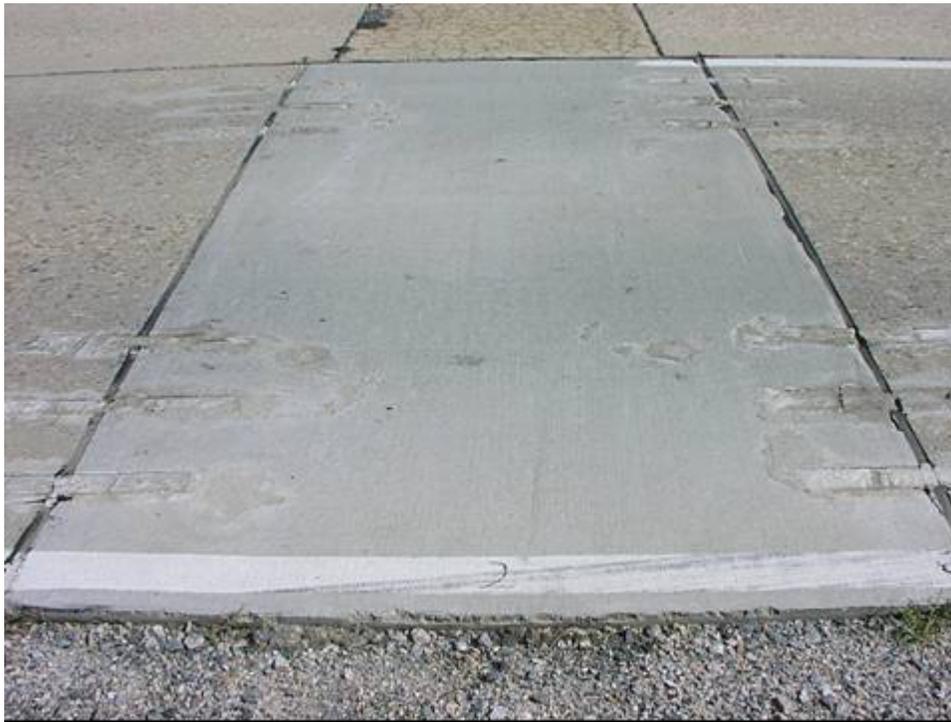
Figure 1. Discontinuous joint at dowel retrofit.

In the survey at 1.5 years, the contractor indicated that during installation of the slabs with pre-fabricated dowels, difficulties were encountered in aligning and centering the dowels. There is also some evidence of misalignment as indicated by cracks initiating at the corners of the dowel slots. The joint locations and dowel retrofit areas were exhibiting the problems and required more attention during construction. Specifically, in the first two patches, the grouted area was continuous between the new slab and the old pavement. The joint was not cut at that location, as shown in Figure 1. Thus, the joints at the slots were filled with grout instead of silicone. Three of the dowels in Slab 1 and all 12 in Slab 2 were reset or reinstalled within 2 months of initial construction. It is speculated that the slots were not cleaned well before grouting during the initial construction.

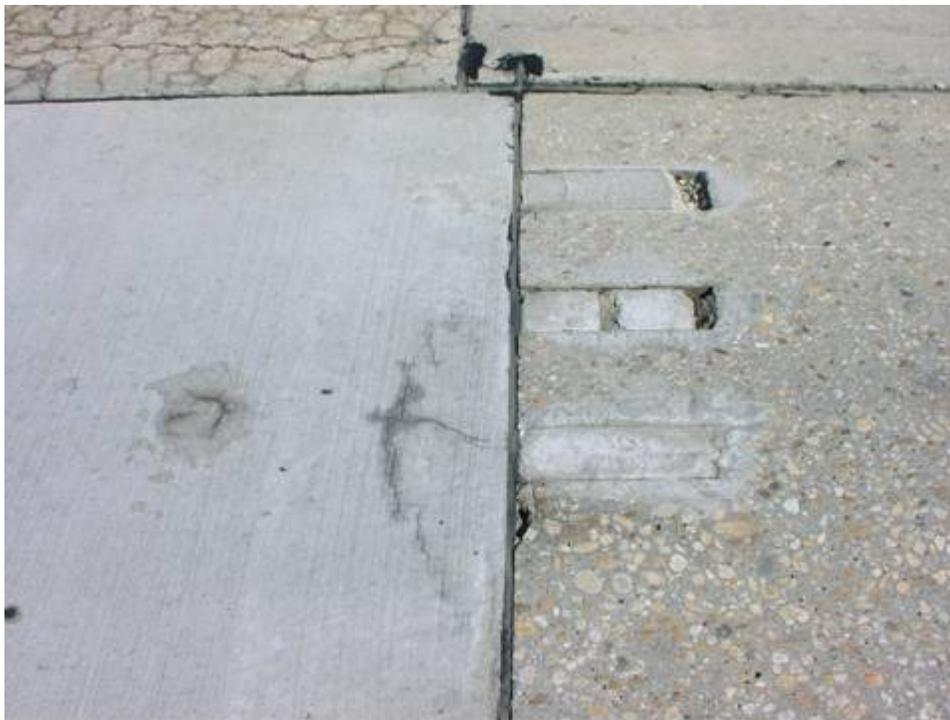
Figure 2. Cracks propagating into patch cast with dowel.

The field survey at 1.5 years, summarized in Table 3, provides more information on the lack of proper jointing between old and new slabs. According to the field survey, Patches 2 and 3 exhibited the worst grout conditions with more cracking. Patches 4, 5, and 6 (preinstalled dowels) were in relatively better condition than Patches 1, 2, and 3 (retrofitted dowels). Table 3 provides the number of cracked or spalled grout areas. In all three slabs cast with dowels, cracks were observed propagating into the patch because of the presence of dowel, as shown in Figure 2. In all patches, there were grouted areas with cracks. All except one of the slabs had spalled joint areas; in one area, the dowel was visible, as shown in Figure 3. In two of the patches cast with dowels, cracks were noticed propagating between the wheelpaths in a region

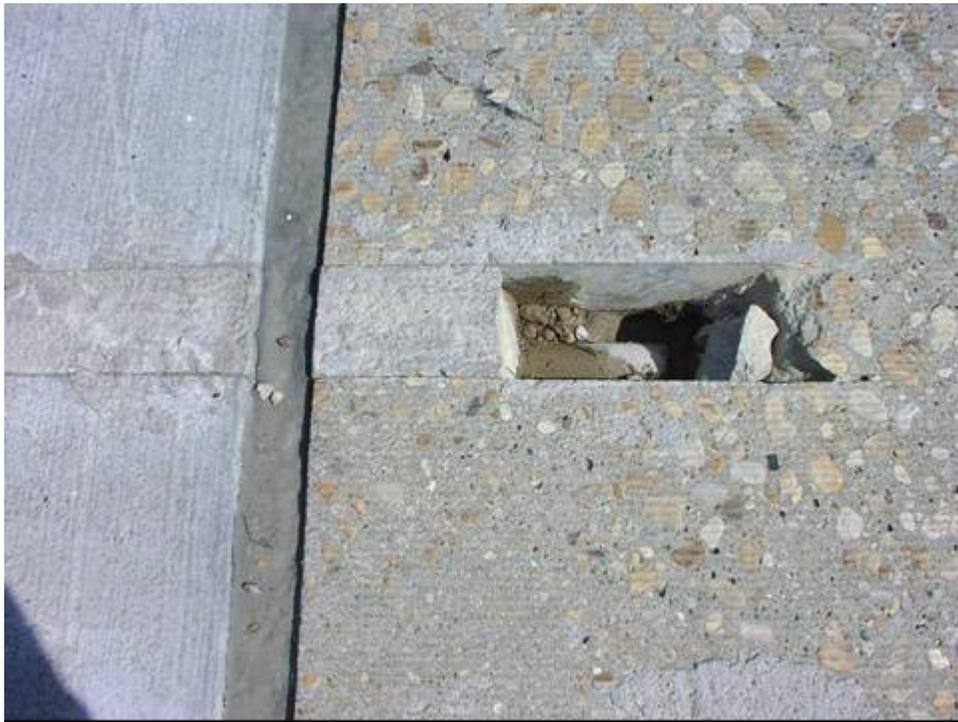
Figure 3. Exposed dowel.

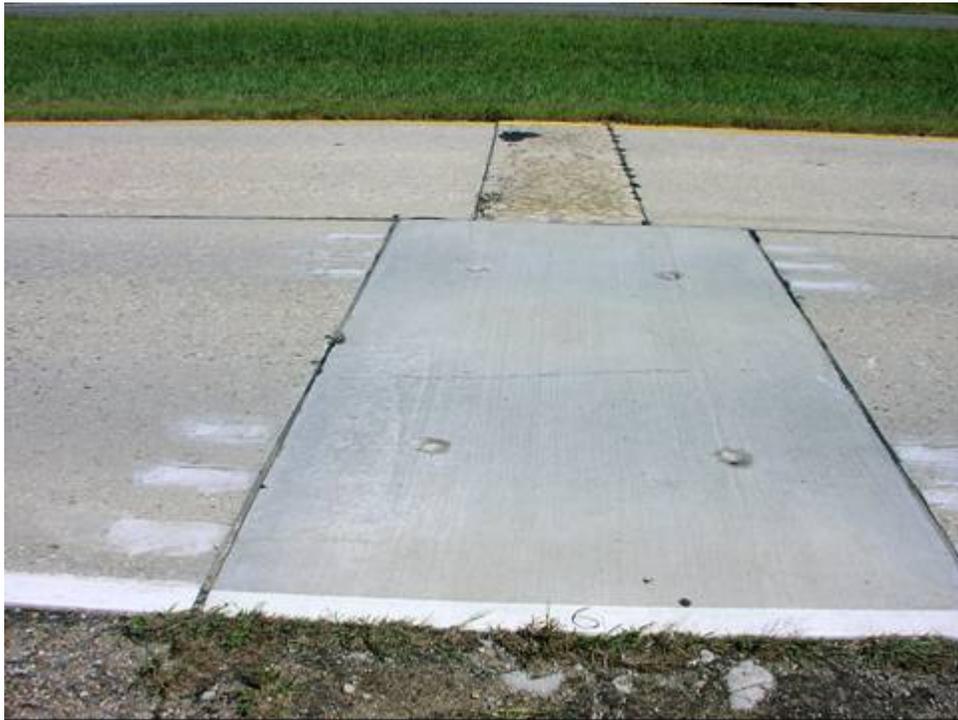
Figure 4. Crack propagating between wheelpaths in patch with cast-in dowel.

without dowels, as shown in Figure 4. In limited areas, the silicone joint material was missing or its surface was depressed up to 1 in. (25 mm) below the top of the slab as shown in Figure 5. This also indicates the need for better construction practices.

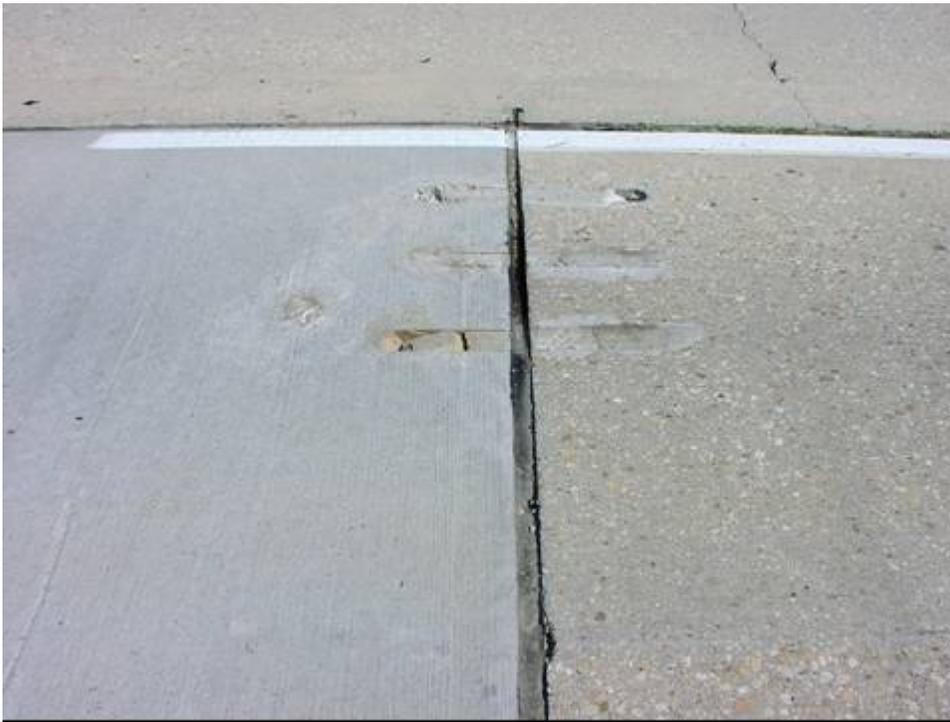
Figure 5. Missing silicone joint sealer.
